Manhole Inspection Summary

Manhole # S09QQ1014MH

Insp Date: **1/21/09 11:56 AM**

Location Address: **5050 SPAULDING AVE**

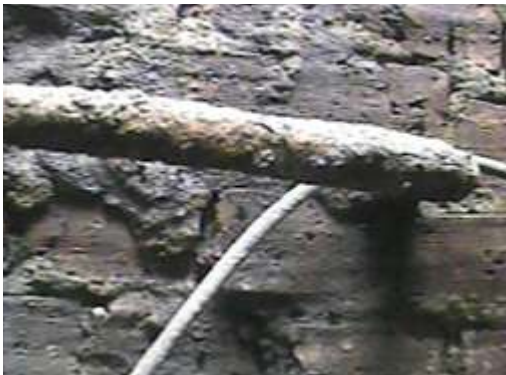
Defect 1

Count: **2** Missing: **0** ☒ **Corroded**

CORRODED STEPS

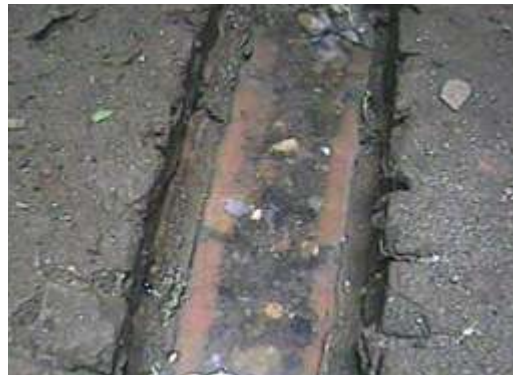
Defect 4

DEBRIS IN CHANNEL

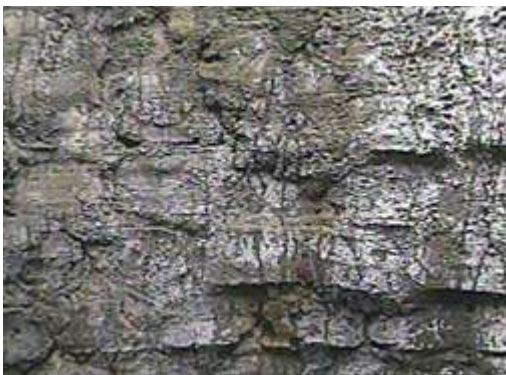
Defect 3

Infiltration: ☐ None ☒ **Joint** ☐ Cracks ☐ Mortar ☐ Roots ☐ Wall

EVIDENCE OF INFILTRATION/
WEEPING ON CORBEL WALL

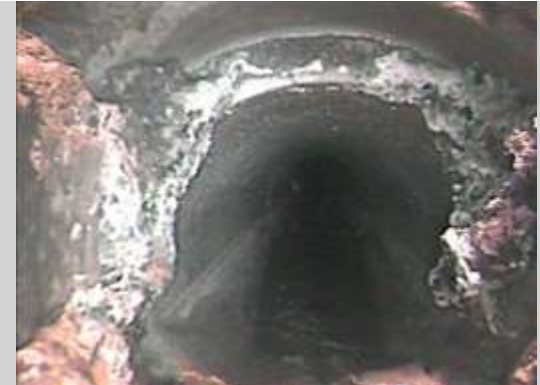
12 O'Clock Outflow

8 in. Circular Gravity Sewer
Pipe Out @ 12 O'Clock

Pipe Height: (in.) Direct
Pipe Material: **Clay** ☐ Pipe Lined
Invert Depth: **7.47** (ft.) Flow Characteristics: **Slow**
Deposits: ☐ None ☐ Mud ☐ Sludge ☐ Debris ☒ Grease
Silt Depth: **1** (in.) Deposits Extent: **Medium**
Infiltration: **Evidence** Pipe Seal Cond: **Broken**

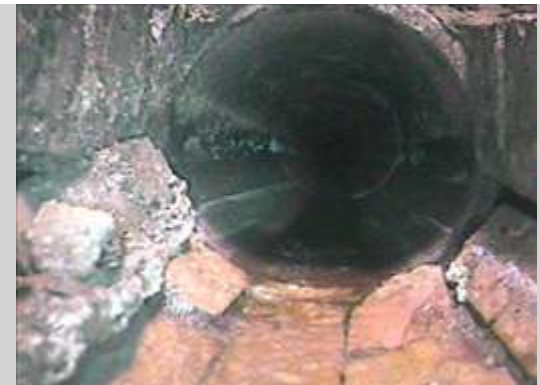
6 O'Clock Inflow

10 in. Circular Gravity Sewer
Pipe In @ 6 O'Clock

Pipe Height: (in.) Direct
Pipe Material: **Clay** ☐ Pipe Lined
Invert Depth: **7.53** (ft.) Flow Characteristics: **Slow**
Deposits: ☒ None ☐ Mud ☐ Sludge ☐ Debris ☐ Grease
Silt Depth: (in.) Deposits Extent:
Infiltration: **None** Pipe Seal Cond: **Sound**
